Mogambo Irrigation Project

Flood Relief Channel Head Regulator
Report on 1985 Scour Damage

Sir M MacDonald & Partners Limited

November 1985

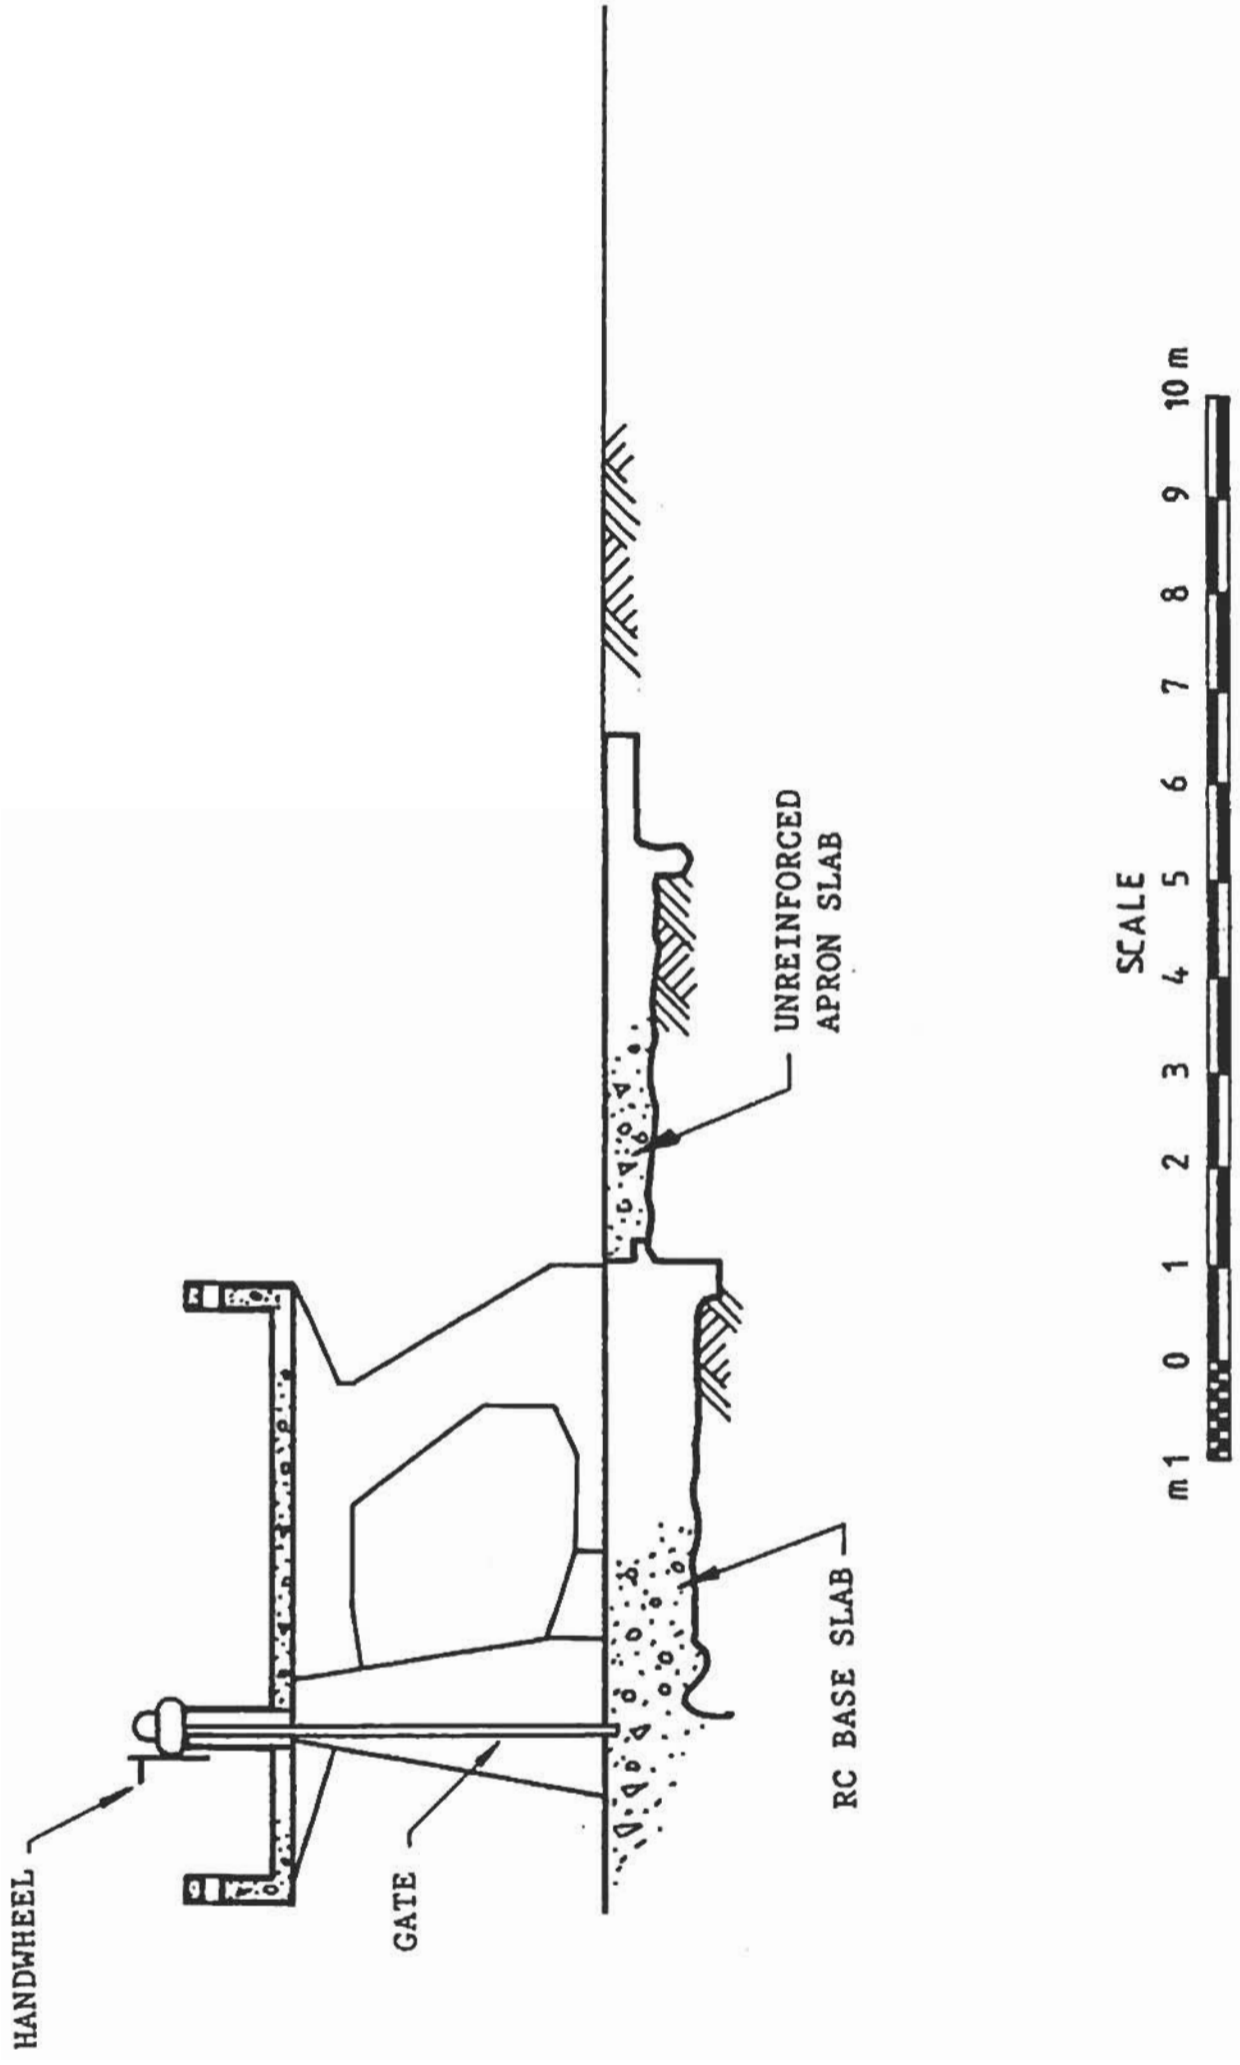
Figure 1

The flood relief channel at Bulo Yaag, with its gated head regulator, was built in the 1950s to alleviate flooding in the banana plantations near the river downstream. The regulator is a concrete structure some 50m long with thirteen steel lifting gates each 2.15m wide and with a maximum clear opening height of 2.0m. It has a roadway 4.1m wide immediately downstream of the gates, which are operated by manual headgear on a walkway alongside the roadway (Figure 1). The invert at this structure is at a level of 10.1m above datum, but the channel invert was, at least by the late 1970s, significantly above that level, up to about 12.0 within the first kilometre. As a result, the discharge in the channel was, except for small gate openings, limited not by the regulator but by the channel. It is probable that the maximum flow was of the order of $20\text{m}^3/\text{s}$, although the regulator would be able to pass more than $100\text{m}^3/\text{s}$ if not drowned out. The level floor of the regulator extended 5m from the gates as a thick reinforced concrete slab, then a further 5.5m as an unreinforced concrete slab. The two slabs met in a stepped butt joint (Figure 1).

Regulator Cross-Section as it was in 1981

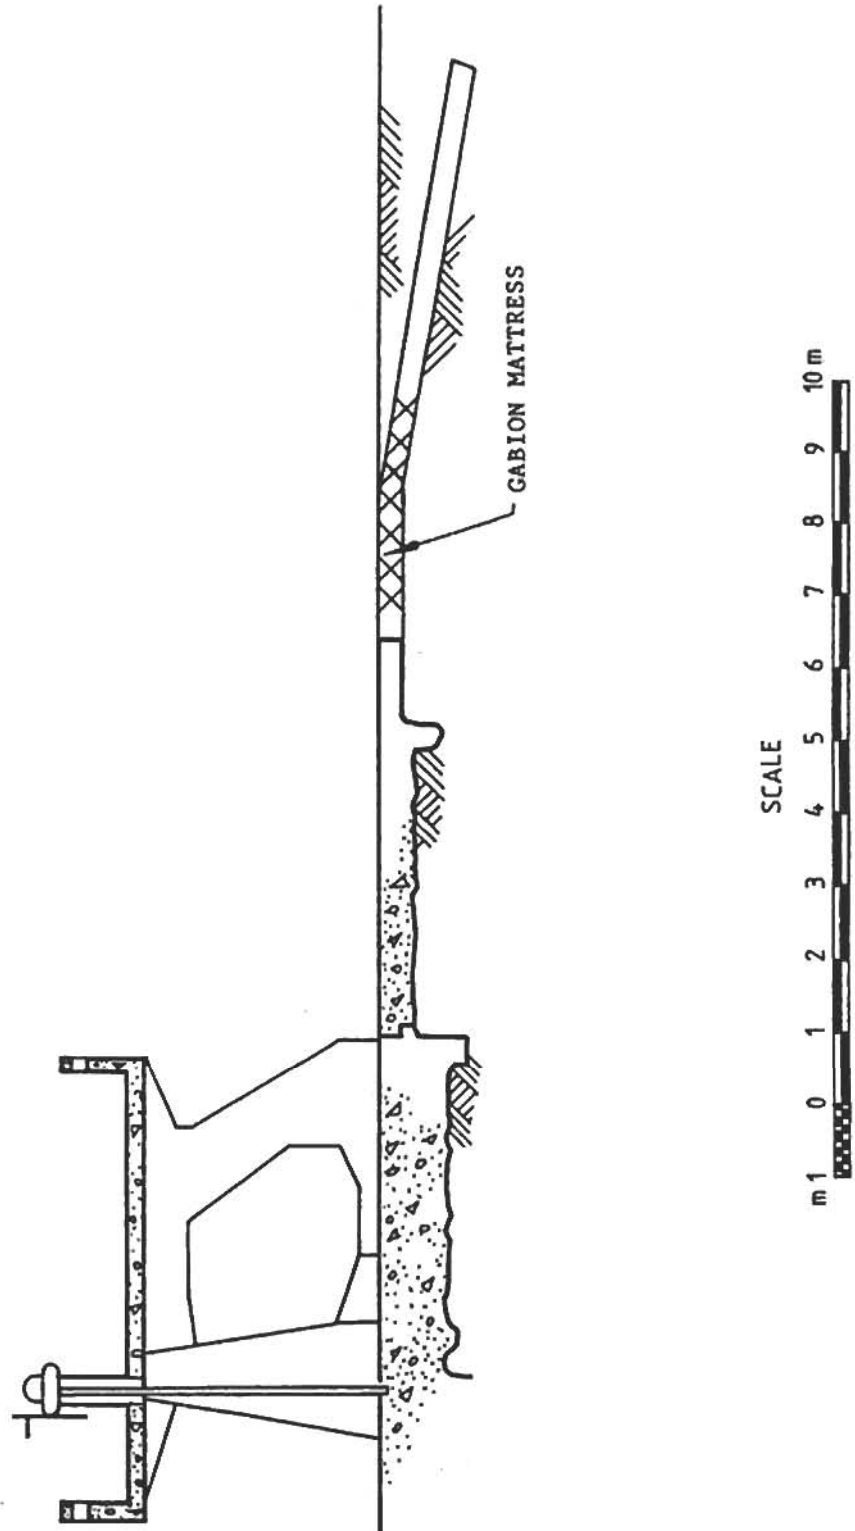
The original MIP Feasibility Study by TAMS/FINTECS (1977, ref.1) proposed that the flood relief channel should be retained and should discharge into the irrigation project's main drain. The Supplementary Feasibility Study of 1979 (MMP, Ref. 2) also proposed the retention of the channel, after considering and rejecting the alternative of closing it and accepting the consequent increase of flooding of the banana plantations, or the need for higher bunds to protect them. But the channel's discharge was to be led round the north and west perimeter of the project (ref. 2, Annex 5, Chapter 1). This proposal was accepted and the flood relief channel was remodelled and, in part, realigned (ref. 4, Plates 5, 18, 19). The channel bed was lowered so that it began at the regulator invert level (10.51m above datum) and sloped at 0.00029. This enabled the channel to pass, probably for the first time, the full design discharge of $100\text{m}^3/\text{s}$. At the same time the regulator's erosion protection was extended: a gabion mattress was laid extending 8m downstream from the older concrete apron slab, its downstream end being 1m below the channel bed level (Figure 2). The banks were protected by gabion mattresses with a small turn-down.

The hydraulic characteristics of the regulator and the flood relief channel are such that, if some of the gates are opened while others are shut, or if gates are opened rapidly, the tailwater level immediately downstream of the structure can be too low to make the hydraulic jump occur on the apron. This would cause high-energy supercritical flow to extend onto the unprotected channel bed and to scour it. It was to protect the structure from the effects of such scour that the gabion mattress was laid in a gentle slope (1:6) down to 1m below channel bed level (Figure 2).

Regulator Cross-Section as it was in April 1985

The protection downstream of the outer six bays is to be restored to the state of early 1985 (Figure 2), except that the gabion mattress is to be attached to the downstream edge of the old concrete apron and the attachment of gabion baskets to each other is to be improved slightly from the former spacing between ties of roughly 0.7m to a spacing of less than 0.5m.

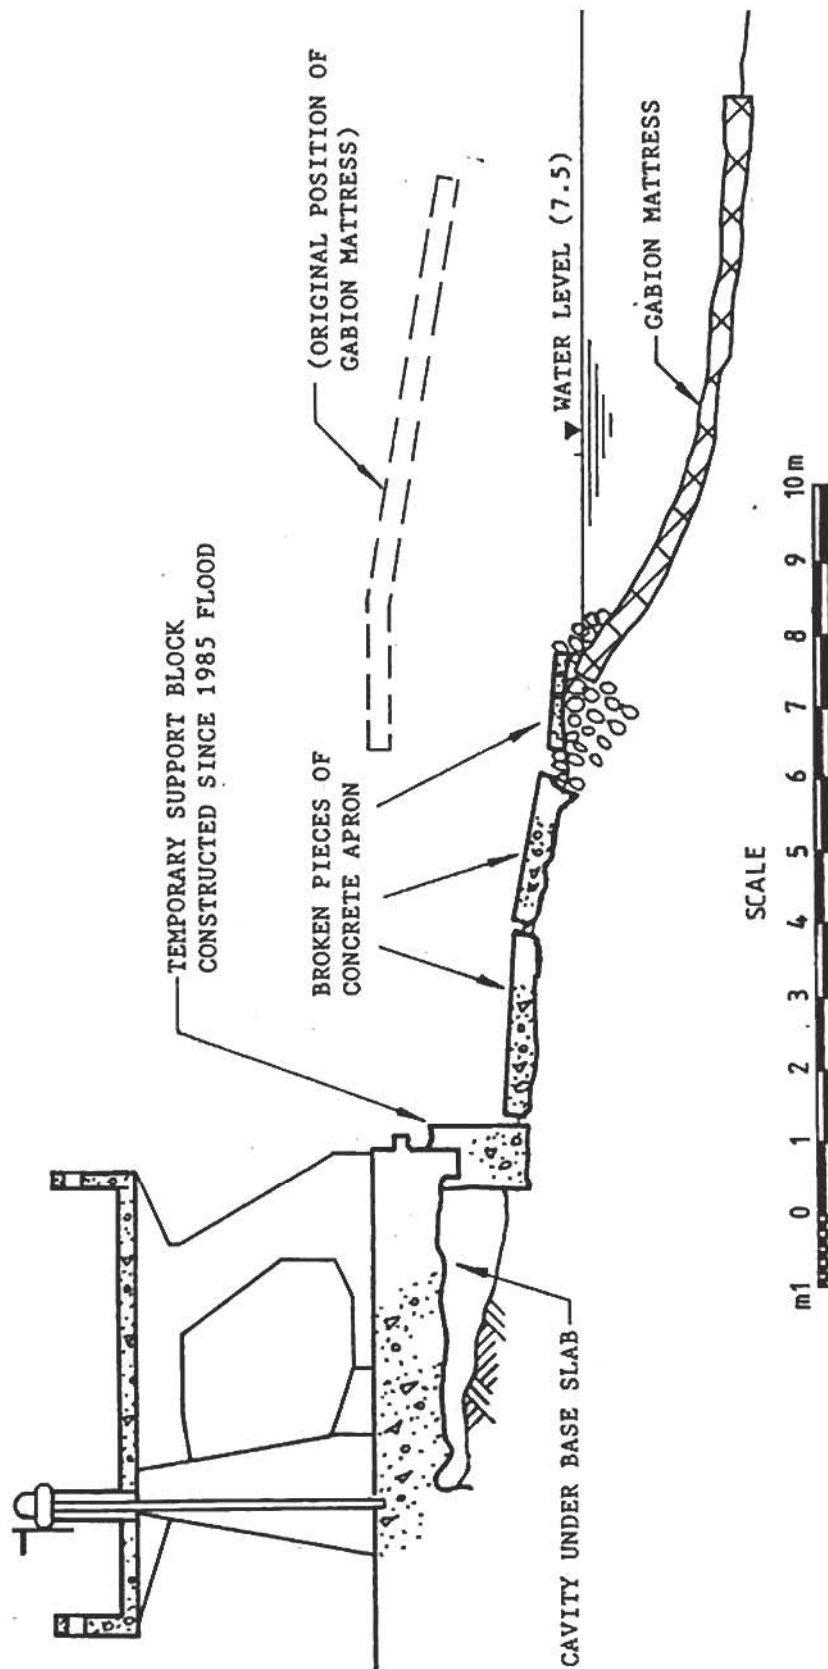
Figures 3 and 4 and Photographs 1 to 5 show the extent and nature of the damage. Over almost the whole width of the channel the new gabion mattress remained intact and lined the sides of the scour hole, even at slopes steeper than 45°. Centrally it fell by up to 5m but moved less than 1m in a downstream direction (remnants of gabions visible at the downstream end of the scour hole, Photographs 4 and 5, came from an old gabion sill, presumably placed many years ago, and have nothing to do with the gabion mattress). The central downstream part of the old concrete apron, about 300mm thick and unreinforced, broke into several pieces which fell partly on top of the gabion mattress (Photograph 2). The rest of the central third of the concrete apron, 500mm thick and unreinforced except for a very lightly reinforced small downstand beam, broke into a few large pieces (Photograph 3).

During the 1985 flood, with the outer six gates shut but overtopped, it is estimated that some 60 to 70m³/s passed through the central seven gates. This means an intensity of flow (discharge per unit width) roughly 30% higher than the design condition (100m³/s through thirteen gates). It seems most probable that this high intensity, coupled with a relatively low tailwater level corresponding to 70 or 80m³/s flowing down the recently remodelled relief channel, caused the supercritical flow to extend beyond the new gabion mattress in the middle of the channel, even after scour had lowered the bed by 1m. The scour hole would then have undermined the gabion mattress, which, being flexible, was able to subside and line the scour hole. It appears however that the slight movement of the gabion mattress allowed turbulent water flow to penetrate between the downstream edge of the concrete apron and the gabion mattress, and then to undermine the apron. This would lead to progressive collapse of the unreinforced apron. Because the apron was not positively attached to the regulator base slab, but only resting on a step in the interface (Figures 1 and 2), this would immediately expose the soil under the apron and immediately downstream of the base slab to the scour action of turbulent water with energy corresponding to a velocity of about 5m/s. It was evidently this scour which eventually reached the underside of the 1.2m deep beam along the edge of the base slab, undermining it and part of the slab itself.

Cross-Section at Centre of Regulator as it was in September 1985

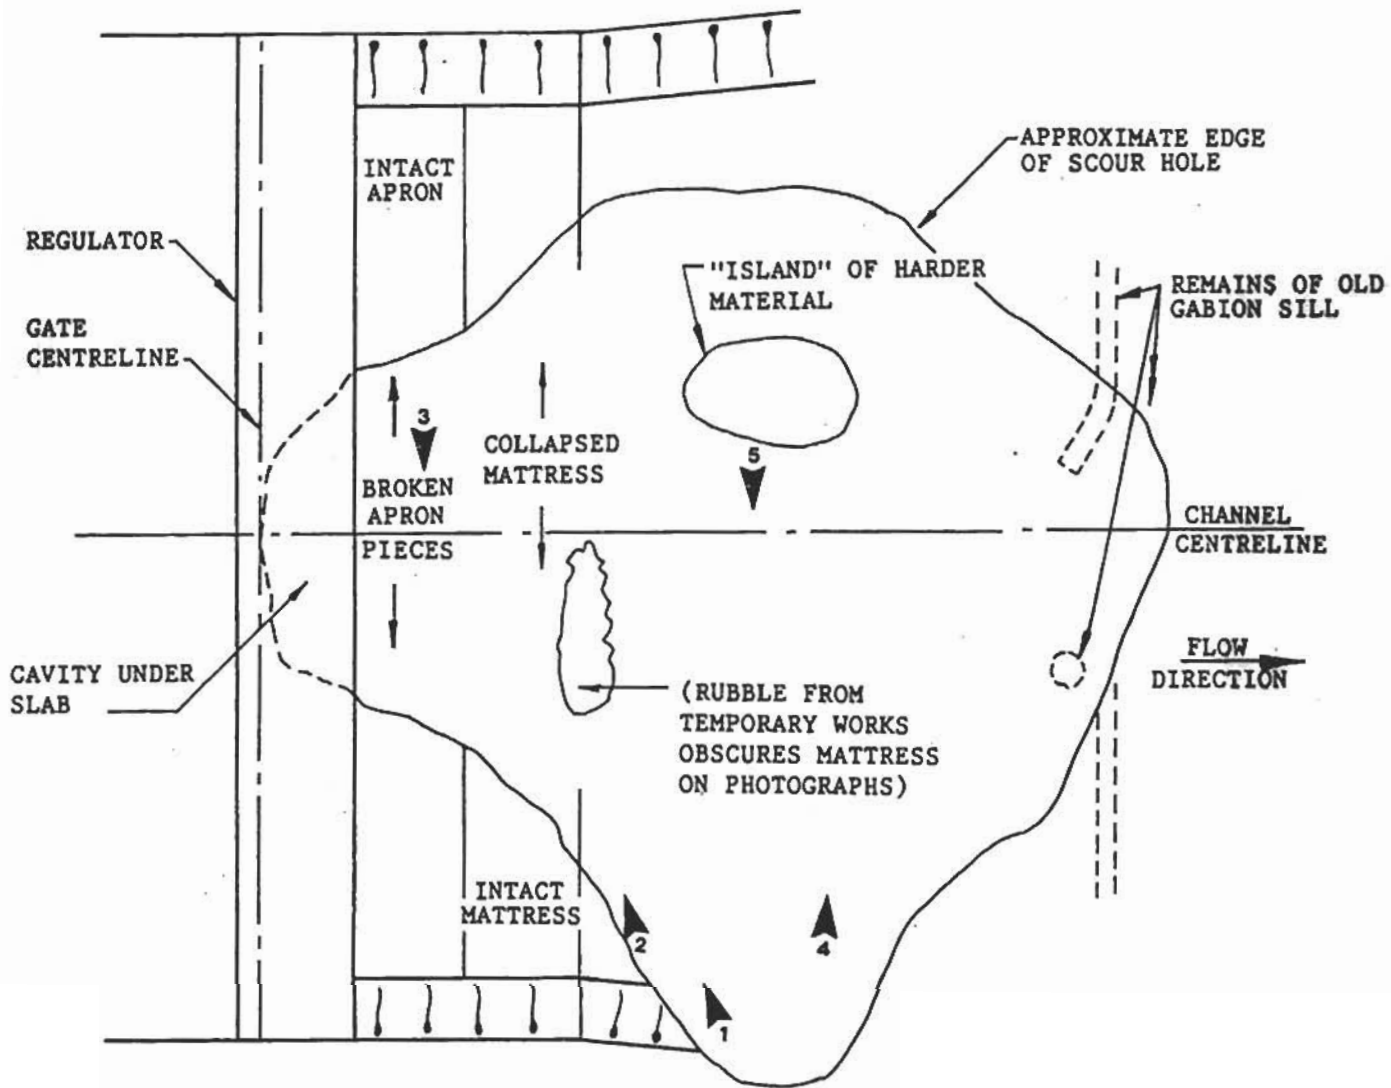
Figure 4
Extent of Scour Hole
in September 1985

When the flood receded it was found that a large hole had been scoured in the channel bed immediately downstream of the regulator. Opposite the central five bays of the thirteen-bay structure the gabion mattress and concrete apron had been undermined and had dropped into the hole, and the soil had been scoured out from underneath the regulator base slab. Over a width of about 4m this scour had reached the downstream face of a deep vertical cutoff wall under the gates, but the strip of this face that was exposed was only 200 to 300mm deep. The base slab did not fail or move and remained spanning the void. Apart from the structurally independent downstream apron, there was thus no damage to the regulator, and no water flowed under the structure.

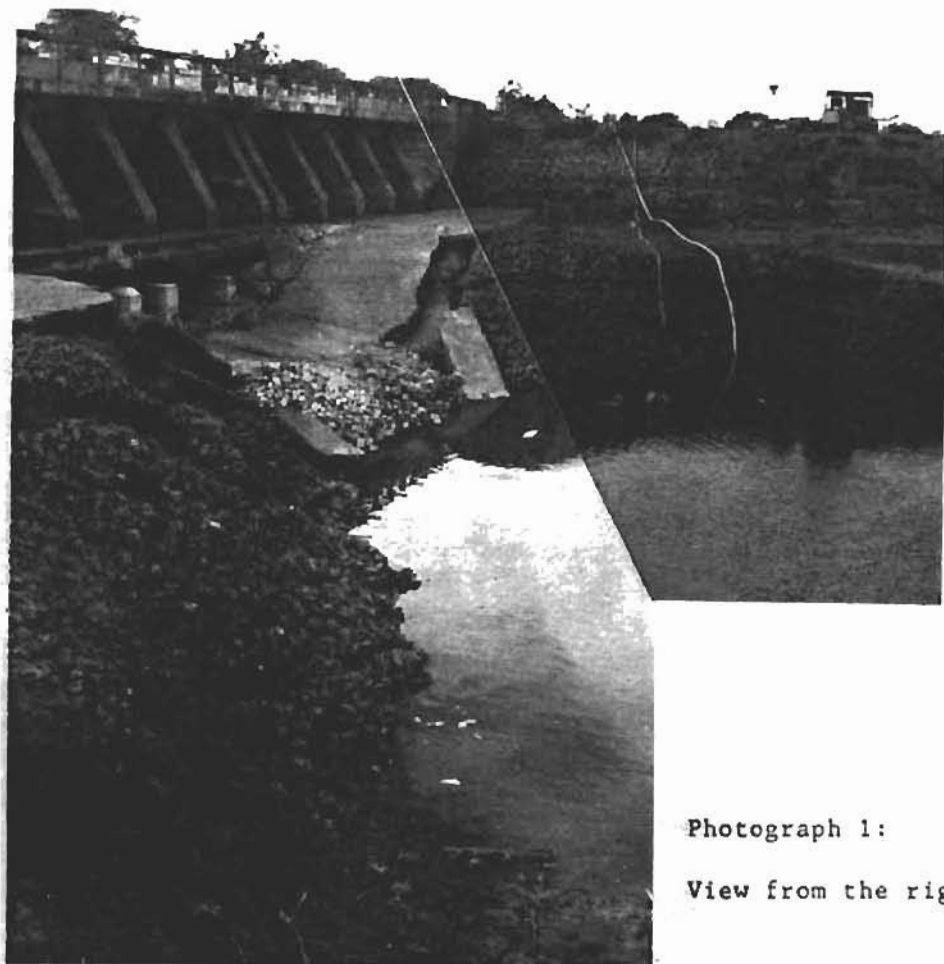
Photograph 1:

View from the right bank

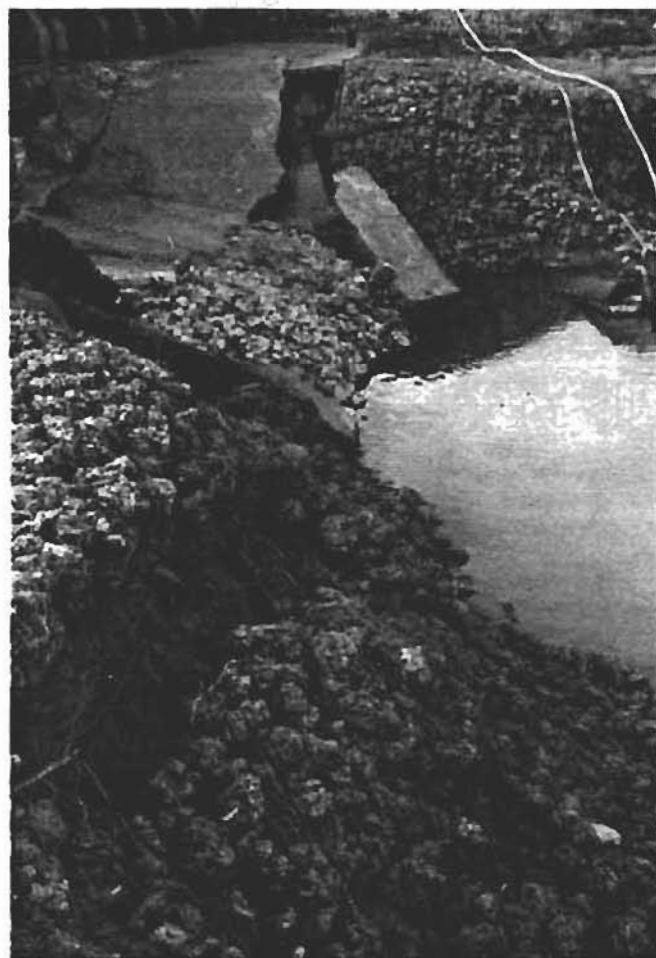
Photograph 2:

Detail of deformed
gabion mattress

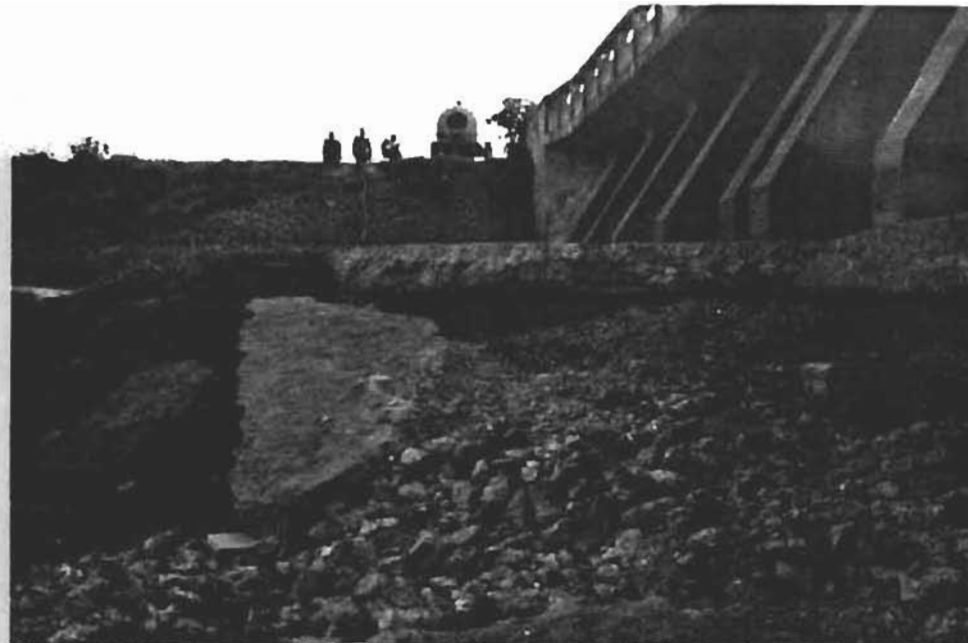
Photograph 3:
The concrete apron

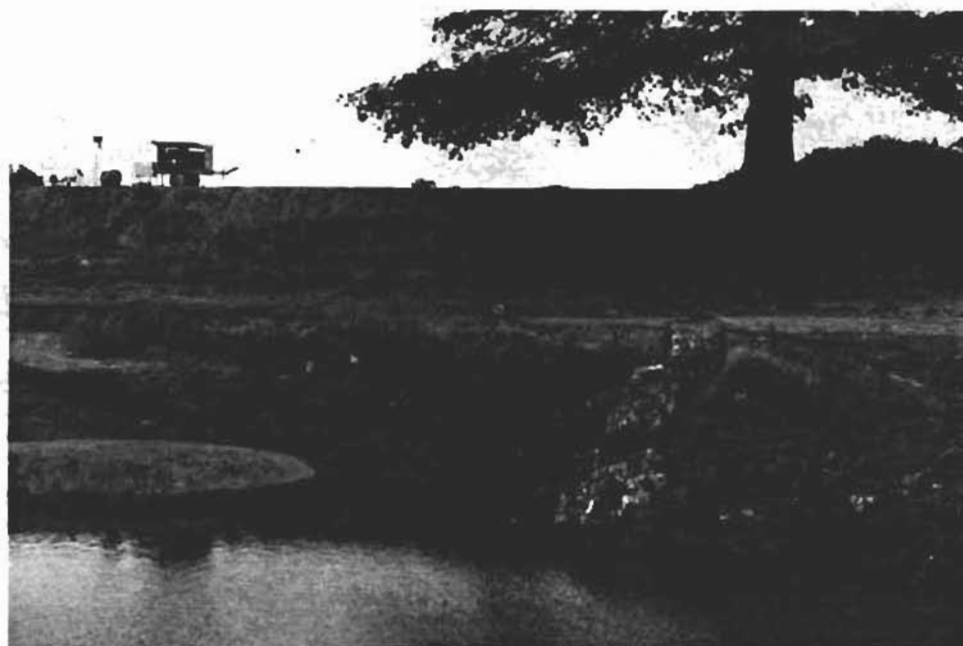
Photograph 4:
Looking towards the
left bank
